OIA-2024-5133

FLOC NK278 - Asbesots Option Study

Interim Asbestos Refurbishment and Demolition Survey Report

Commissioned by	New Zealand Defence Force (NZDF)
Site Address	Officers Training School, NZDF FLOC: NNK278, Narrow Neck, Auckland 0624
Inspection Dates	4 July 2019 11 July 2019 12 July 2019 22 July 2019
Weather Condition	Fine,
Inspected By	Jack Adlam, BSc, Asbestos Assessor, Maynard Marks
Other Persons Present	Simon Paykel, MNZIBS P402 IP404 P405, Licensed Asbestos Assessor, Maynard Marks Robert McAllister, Building Surveyor and Licensed Asbestos Assessor Samisoni Manu, Asbestos Assessor, Maynard Marks Rita Lehn, Asbestos Assessor, Maynard Marks

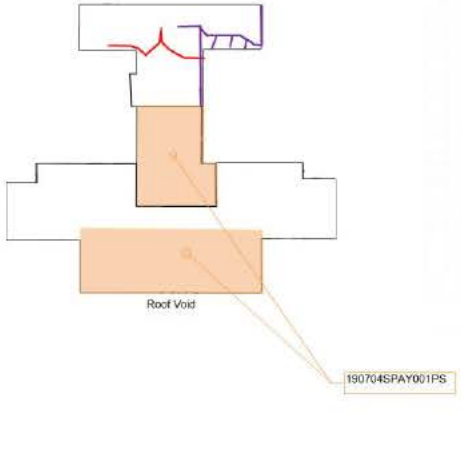
Unique No.	Description	Location	Result	Observations and Recommendations	
190704SPAY001PS	Pipe Lagging / Fibre Cement Debris + ACD	Central Block, NZDF FLOC: NNK278 All Roof Voids - Throughout	Presumed to contain asbestos	Debris and dust deposits are presumed to originate from the original ACM Super-Six roof that appears to have been very poorly removed. The contamination also includes damaged friable lagging insulation to pipework systems, unsuccessfully removed and still installed to pipes that run throughout the Roof Void. Prior to any refurbishment/demolition works that may disturb the items identified being undertaken, the asbestos identified must be removed. Removal of the asbestos must be undertaken by a licensed asbestos removalist in accordance with Health and Safety at Work (Asbestos) Regulations 2016.	
Assessment Scores					
Material Assessment Score	Risk Rating	Approximate Extent/Area

12	High Risk	Unable to Determine			
Photographic Reference

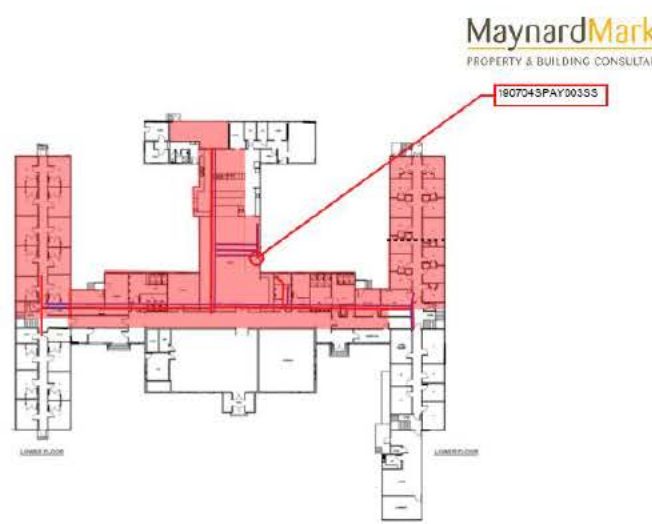
Unique No.	Description	Location	Result	Observations and Recommendations
190704SPAY003SS	Pipe Lagging / Fibre Cement Debris + ACD	Central Block, NZDF FLOC: NNK278 Subfloor Area below Dining Room - On Ground Throughout	Chrysotile (White Asbestos) detected	Prior to any refurbishment/demolition works that may disturb the items identified being undertaken, the asbestos identified must be removed. Removal of the asbestos must be undertaken by a licensed asbestos removalist in accordance with Health and Safety at Work (Asbestos) Regulations 2016.
Assessment Scores				
Material Assessment Score	Risk Rating	Approximate Extent/Area		
10	High Risk	50m2		
Photographic Reference

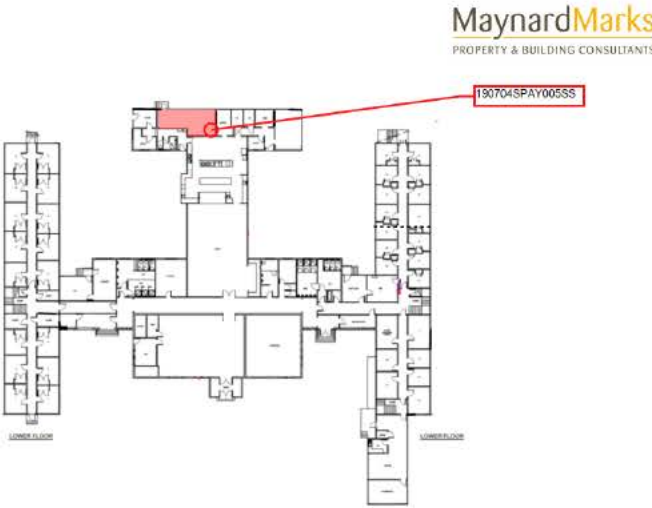
Unique No.	Description	Location	Result	Observations and Recommendations
190704SPAY005SS	Surface Sample - Tape Swab - Dust / Debris	Central Block, NZDF FLOC: NNK278 Boiler Room - Floor Surfaces below Pipework	Chrysotile (White Asbestos) detected	Prior to any refurbishment/demolition works that may disturb the items identified being undertaken, the asbestos identified must be removed. Removal of the asbestos must be undertaken by a licensed asbestos removalist in accordance with Health and Safety at Work (Asbestos) Regulations 2016.
Assessment Scores				
Material Assessment Score	Risk Rating	Approximate Extent/Area		
10	High Risk	Unable to Determine		
Photographic Reference

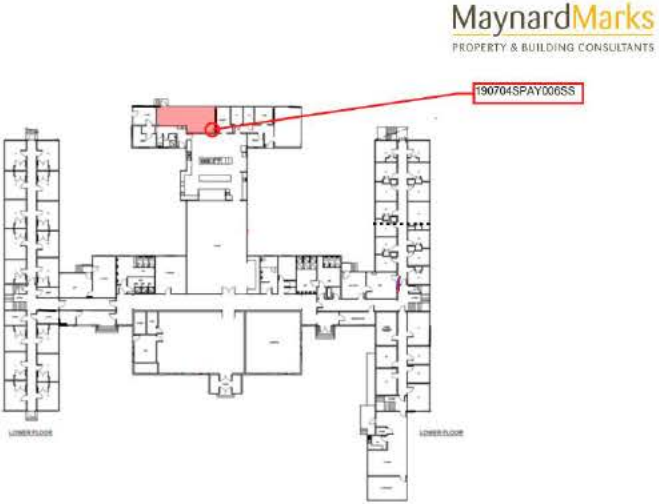
Unique No.	Description	Location	Result	Observations and Recommendations
190704SPAY006SS	Surface Sample - Tape Swab - Dust / Debris	Central Block, NZDF FLOC: NNK278 Boiler Room - Cable tray to Control Panel	Chrysotile (White Asbestos) detected	Prior to any refurbishment/demolition works that may disturb the items identified being undertaken, the asbestos identified must be removed. Removal of the asbestos must be undertaken by a licensed asbestos removalist in accordance with Health and Safety at Work (Asbestos) Regulations 2016.
Assessment Scores				
Material Assessment Score	Risk Rating	Approximate Extent/Area		
10	High Risk	Unable to Determine		
Photographic Reference

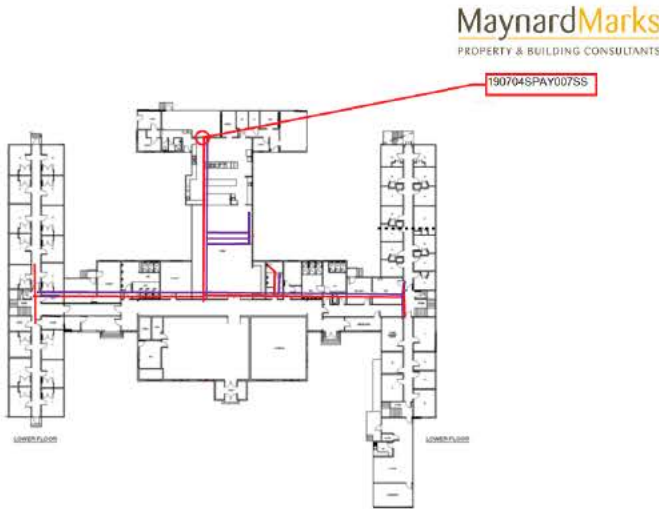
Unique No.	Description	Location	Result	Observations and Recommendations
190704SPAY007	Pipe Lagging / Insulation	Central Block, NZDF FLOC: NNK278 Boiler Room - Penetration to Subfloor Area - Pipework	Chrysotile (White Asbestos) detected	Prior to any refurbishment/demolition works that may disturb the items identified being undertaken, the asbestos identified must be removed. Removal of the asbestos must be undertaken by a licensed asbestos removalist in accordance with Health and Safety at Work (Asbestos) Regulations 2016.
Assessment Scores				
Material Assessment Score	Risk Rating	Approximate Extent/Area		
10	High Risk	50m		
Photographic Reference

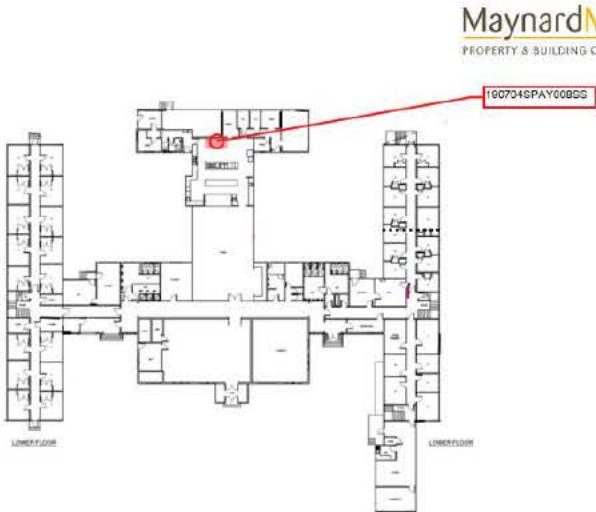
Unique No.	Description	Location	Result	Observations and Recommendations
190704SPAY008	Debris - Gasket Sheet	Central Block, NZDF FLOC: NNK278 Boiler Room - Penetration to Subfloor Area - Upon ground	Chrysotile (White Asbestos) detected	Prior to any refurbishment/demolition works that may disturb the items identified being undertaken, the asbestos identified must be removed. Removal of the asbestos must be undertaken by a licensed asbestos removalist in accordance with Health and Safety at Work (Asbestos) Regulations 2016.
Assessment Scores				
Material Assessment Score	Risk Rating	Approximate Extent/Area		
10	High Risk	1m2		
Photographic Reference

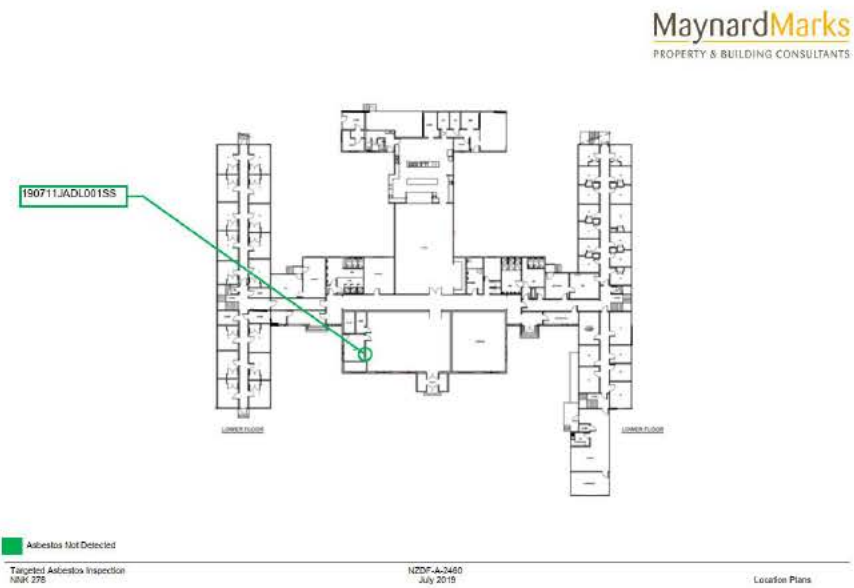
Unique No.	Description	Location	Result	Observations and Recommendations
190711JADL001SS	Surface Sample - Tape Swab (Composite)	Central Block, NZDF FLOC: NNK278 Gunroom - High Level Wall Vent Surfaces 1	Asbestos NOT detected	N/A
Assessment Scores				
Material Assessment Score	Risk Rating	Approximate Extent/Area		
N/A	N/A	Unable to Determine		
Photographic Reference

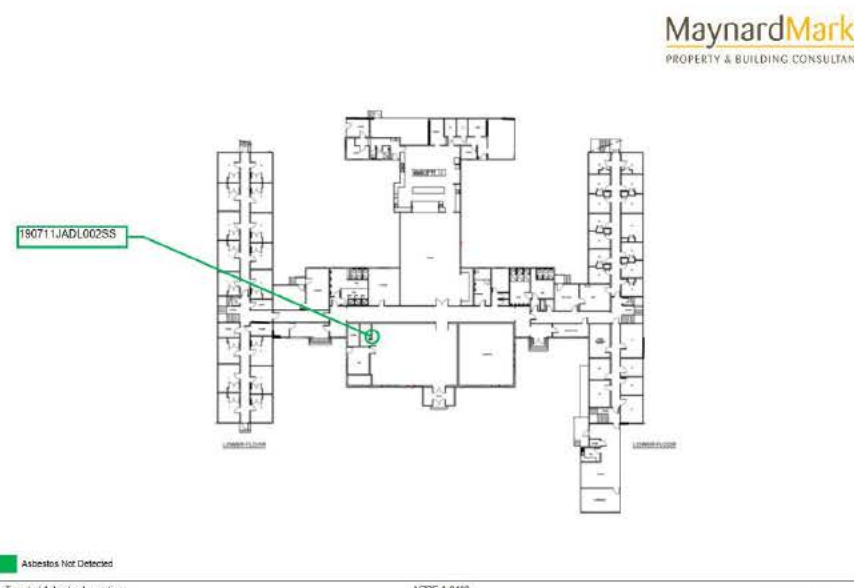
Unique No.	Description	Location	Result	Observations and Recommendations
190711JADL002SS	Surface Sample - Tape Swab (Composite)	Central Block, NZDF FLOC: NNK278 Gunroom - High Level Wall Vent Surfaces 2	Asbestos NOT detected	N/A
Assessment Scores				
Material Assessment Score	Risk Rating	Approximate Extent/Area		
N/A	N/A	Unable to Determine		
Photographic Reference

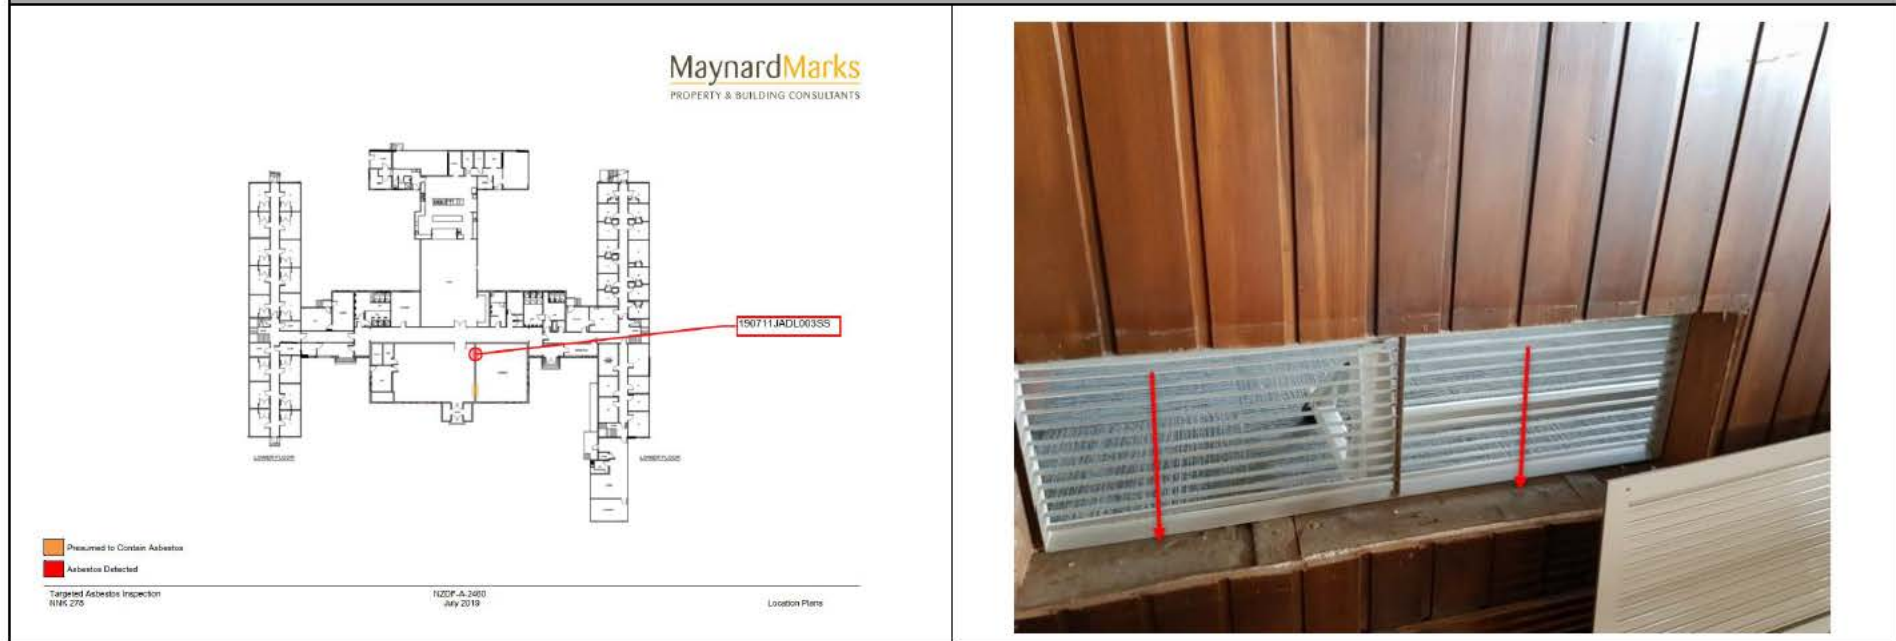
Unique No.	Description	Location	Result	Observations and Recommendations
190711JADL003SS	Surface Sample - Tape Swab (Composite)	Central Block, NZDF FLOC: NNK278 Gunroom/Anteroom - Passive Wall Vent Internal Surfaces between Gunroom and Anterooms	Chrysotile (White Asbestos) detected	Prior to any refurbishment/demolition works that may disturb the items identified being undertaken, the asbestos identified must be removed. Removal of the asbestos must be undertaken by a licensed asbestos removalist in accordance with Health and Safety at Work (Asbestos) Regulations 2016.
Assessment Scores				
Material Assessment Score		Risk Rating	Approximate Extent/Area	
10		High Risk	Unable to Determine

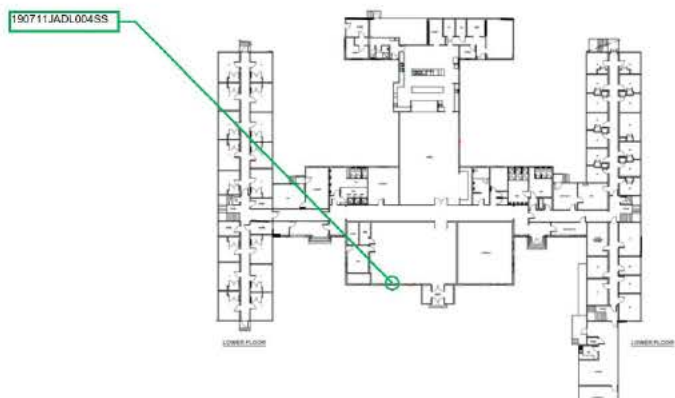
Unique No.	Description	Location	Result	Observations and Recommendations
190711JADL004SS	String/Rope (Composite)	Central Block, NZDF FLOC: NNK278 Gunroom Windows to Exterior - Sash Cords	Asbestos NOT detected	N/A
Assessment Scores				
Material Assessment Score	Risk Rating	Approximate Extent/Area		
N/A	N/A	Unable to Determine		
Photographic Reference

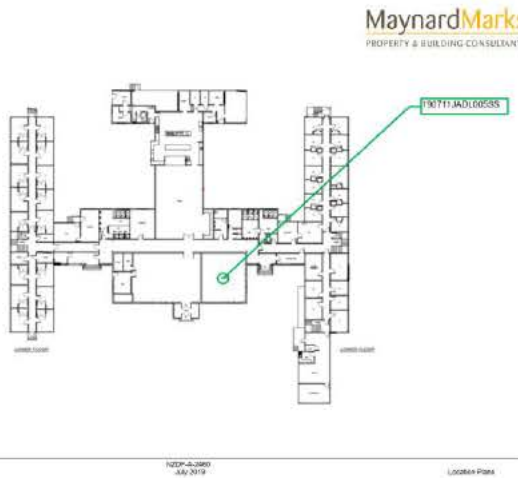
Unique No.	Description	Location	Result	Observations and Recommendations
190711JADL005SS	Surface Sample - Tape Swab (Composite)	Central Block, NZDF FLOC: NNK278 Anteroom - High Level Ceiling Vent Surfaces	Asbestos NOT detected	N/A
Assessment Scores				
Material Assessment Score	Risk Rating	Approximate Extent/Area		
N/A	N/A	Unable to Determine		
Photographic Reference

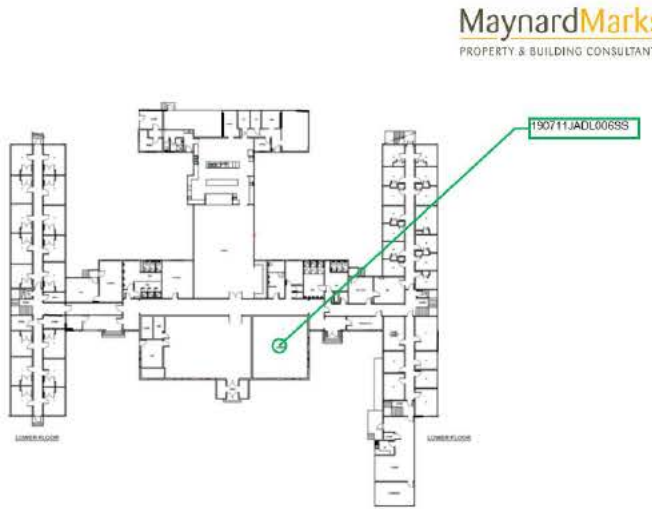
Unique No.	Description	Location	Result	Observations and Recommendations
190711JADL006SS	Surface Sample - Tape Swab (Composite)	Central Block, NZDF FLOC: NNK278 Anteroom - Floor Surfaces below High Level Ceiling Vents	Asbestos NOT detected	N/A
Assessment Scores				
Material Assessment Score	Risk Rating	Approximate Extent/Area		
N/A	N/A	Unable to Determine		
Photographic Reference

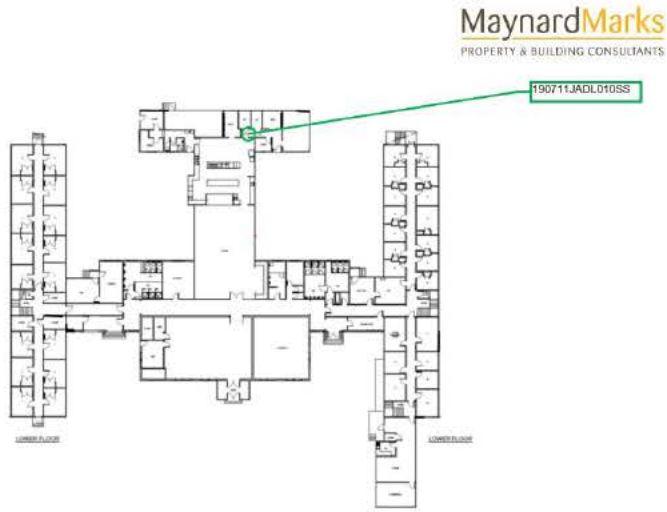
Unique No.	Description	Location	Result	Observations and Recommendations
190711JADL010SS	Surface Sample - Tape Swab (Composite)	Central Block, NZDF FLOC: NNK278 Kitchen Area West - Floor Surfaces below Ceiling Access Hatch	Asbestos NOT detected	N/A
Assessment Scores				
Material Assessment Score		Risk Rating	Approximate Extent/Area	
N/A		N/A	Unable to Determine	
Photographic Reference

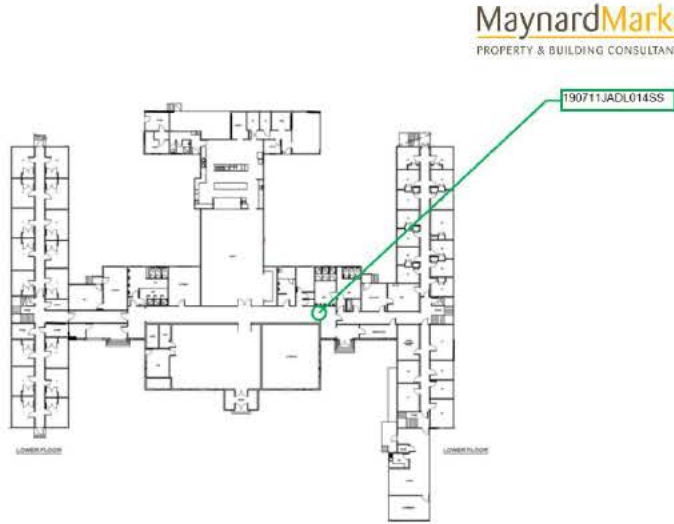
Unique No.	Description	Location	Result	Observations and Recommendations
190711JADL014SS	Surface Sample - Tape Swab (Composite)	Central Block, NZDF FLOC: NNK278 Central Hallway West - Floor Below Ceiling Access Hatch	Asbestos NOT detected	N/A
Assessment Scores				
Material Assessment Score	Risk Rating	Approximate Extent/Area		
N/A	N/A	Unable to Determine		
Photographic Reference

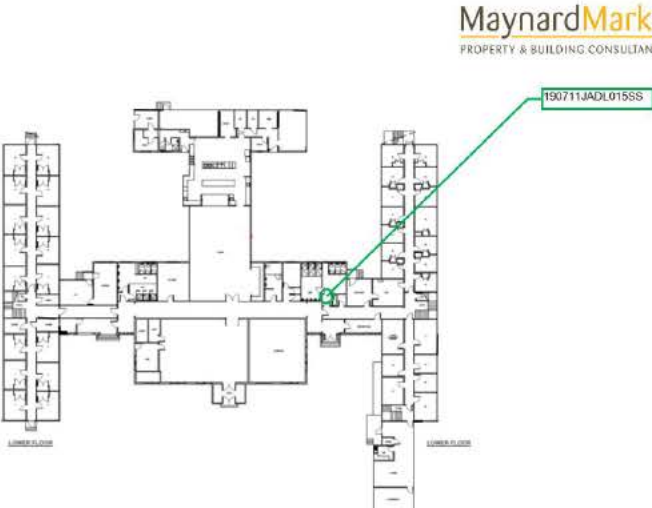
Unique No.	Description	Location	Result	Observations and Recommendations
190711JADL015SS	Surface Sample - Tape Swab (Composite)	Central Block, NZDF FLOC: NNK278 Ground Level Female Bathrooms - Floor Below Ceiling Access Hatch and adj Subfloor Access	Asbestos NOT detected	N/A
Assessment Scores				
Material Assessment Score	Risk Rating	Approximate Extent/Area		
N/A	N/A	Unable to Determine		
Photographic Reference

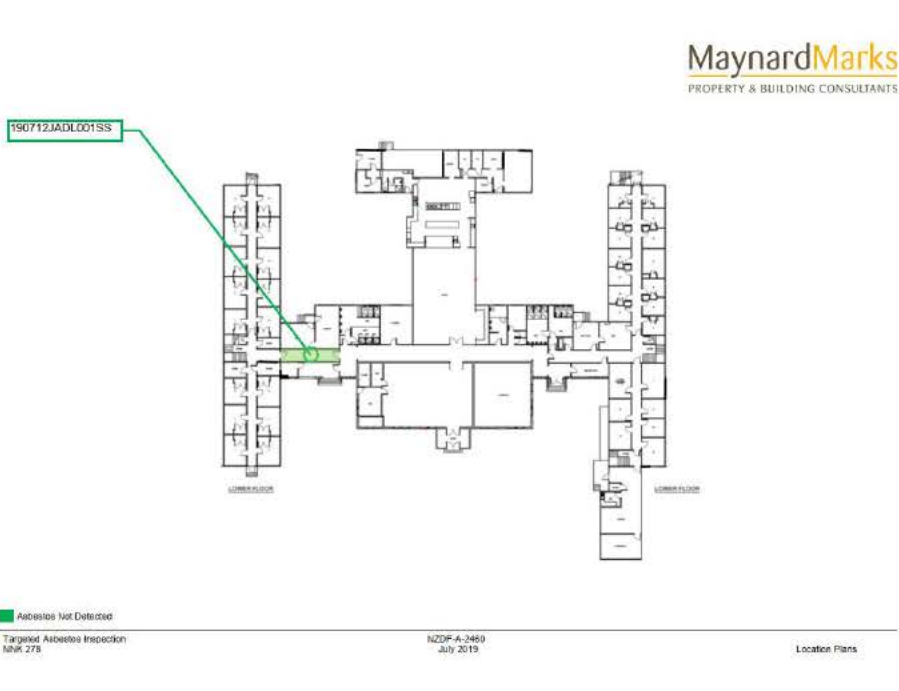
Unique No.	Description	Location	Result	Observations and Recommendations
190712JADL001SS	Vinyl Sheetting (Composite)	Central Block, NZDF FLOC: NNK278 Hallway to East Wing - Floor Covering	Asbestos NOT detected	Material previously presumed positive - Pattle Delamore Partners Asbestos Management Survey Report (28/06/2019) Reference: - NK278_P003. - Material sampled for analysis as 190712JADL001SS with a Negative result for asbestos.
Assessment Scores				
Material Assessment Score	Risk Rating	Approximate Extent/Area		
N/A	N/A	20m2		
Photographic Reference

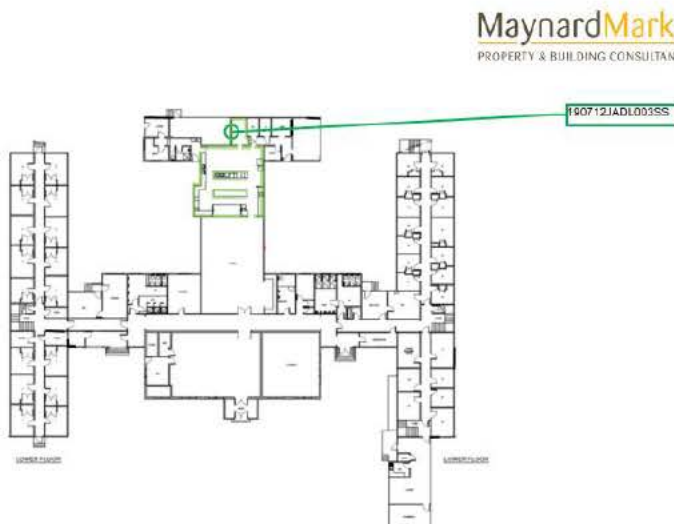
Unique No.	Description	Location	Result	Observations and Recommendations
190712JADL003SS	Fibre Cement (Compressed Sheet)	Central Block, NZDF FLOC: NNK278 Kitchen Area - Prep Room - Wall and Ceiling Linings - Throughout	Asbestos NOT detected	Material previously presumed positive - Pattle Delamore Partners Asbestos Management Survey Report (28/06/2019) Reference: - NK278_P002 - Material sampled for analysis as 190712JADL003SS with a Negative result for asbestos.
Assessment Scores				
Material Assessment Score	Risk Rating	Approximate Extent/Area		
N/A	N/A	N/A		
Photographic Reference

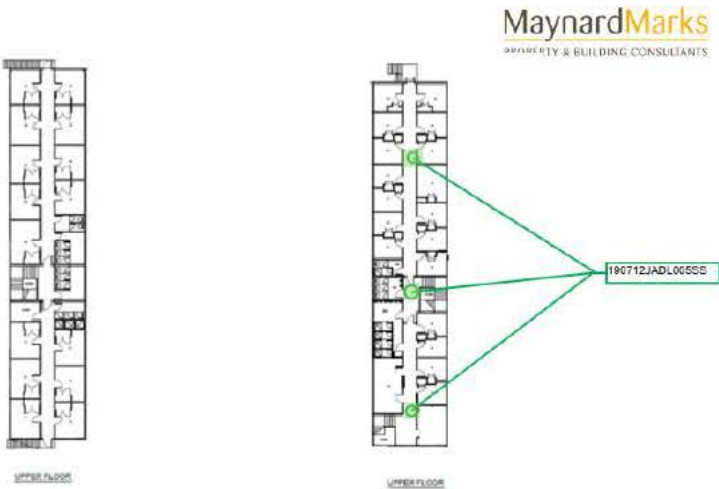
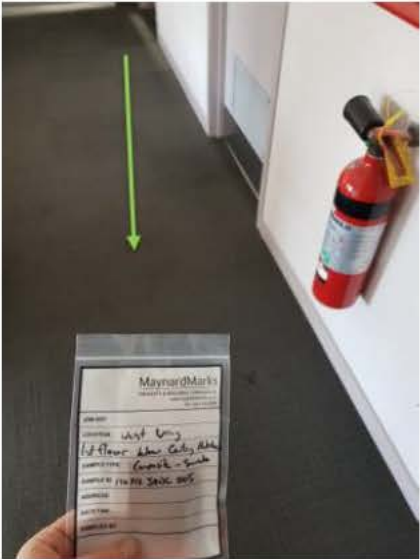
Unique No.	Description	Location	Result	Observations and Recommendations
190712JADL005SS	Surface Sample - Tape Swab (Composite)	West Wing, NZDF FLOC: NNK278 First Floor - Interior Hallway adjacent Bedrooms - Floor Surfaces below Ceiling Access Hatches	Asbestos NOT detected	N/A
Assessment Scores				
Material Assessment Score	Risk Rating	Approximate Extent/Area		
N/A	N/A	N/A		
Photographic Reference

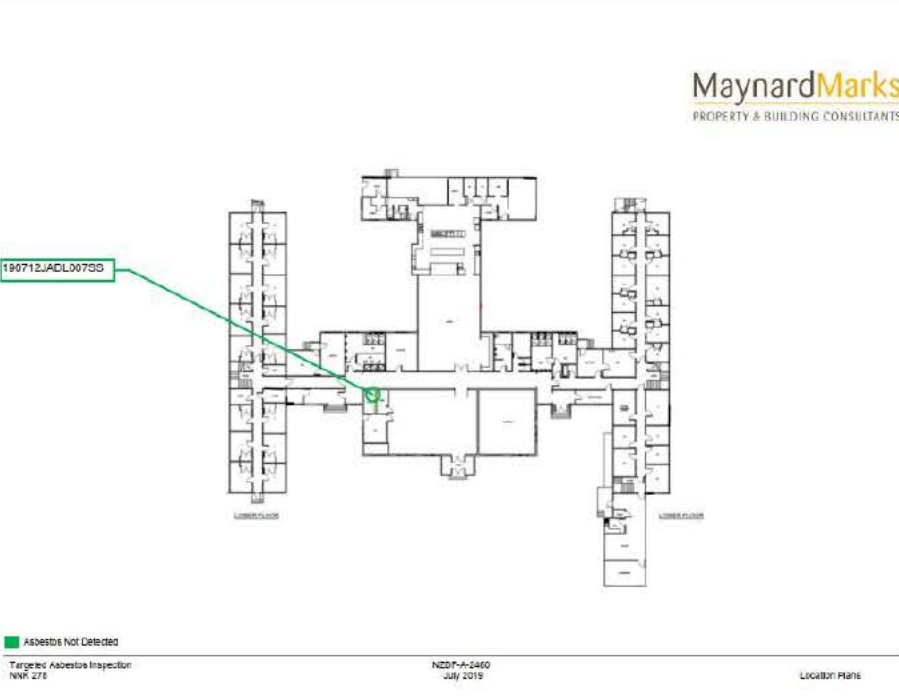
Unique No.	Description	Location	Result	Observations and Recommendations
190712JADL007SS	Fibre Cement (Compressed Sheet)	Central Block, NZDF FLOC: NNK278 Gunroom Bar Kitchenette - Fibre Cement Panel Floor to Doorway	Asbestos NOT detected	N/A
Assessment Scores				
Material Assessment Score		Risk Rating	Approximate Extent/Area	
N/A		N/A	N/A	
Photographic Reference
