OIA-2024-5133

FLOC NK278 - Asbesots Option Study

Interim Asbestos Refurbishment and Demolition Survey Report

Commissioned by	New Zealand Defence Force (NZDF)
Site Address	Officers Training School, NZDF FLOC: NNK278, Narrow Neck, Auckland 0624
Inspection Dates	4 July 2019 11 July 2019 12 July 2019 22 July 2019
Weather Condition	Fine,
Inspected By	Jack Adlam, BSc, Asbestos Assessor, Maynard Marks
Other Persons Present	Simon Paykel, MNZIBS P402 IP404 P405, Licensed Asbestos Assessor, Maynard Marks Robert McAllister, Building Surveyor and Licensed Asbestos Assessor Samisoni Manu, Asbestos Assessor, Maynard Marks Rita Lehn, Asbestos Assessor, Maynard Marks

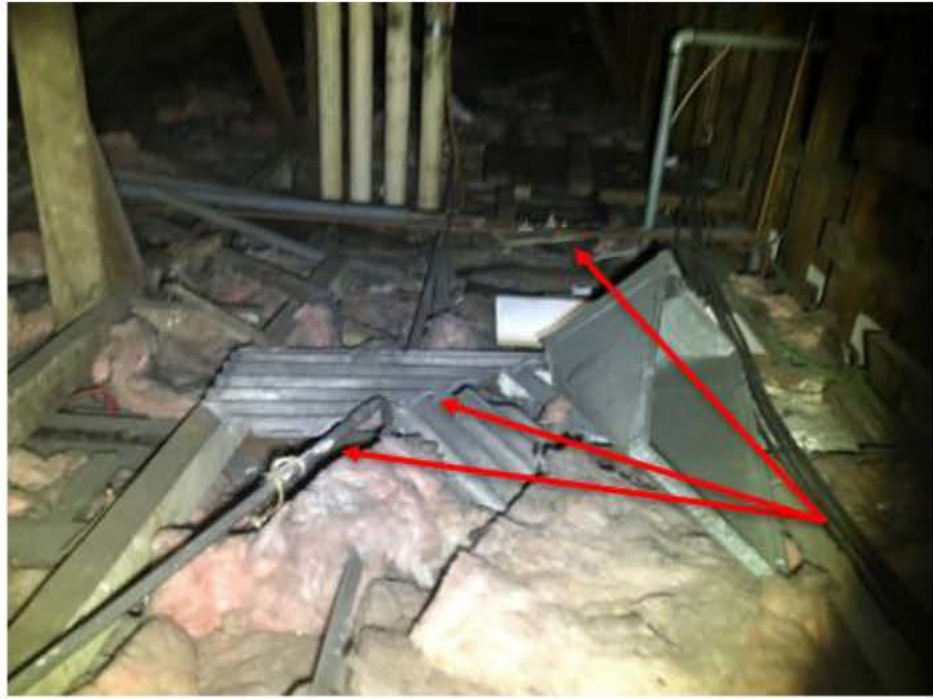
Unique No.	Description	Location	Result	Observations and Recommendations
190704SPAY002SS	Pipe Lagging / Fibre Cement Debris 2	Central Block, NZDF FLOC: NNK278 Roof Void above Kitchen Area - Loose Material Upon Batts	Chrysotile (White Asbestos) and Crocidolite (Blue Asbestos) detected	Prior to any refurbishment/demolition works that may disturb the items identified being undertaken, the asbestos identified must be removed. Removal of the asbestos must be undertaken by a licensed asbestos removalist in accordance with Health and Safety at Work (Asbestos) Regulations 2016.
Assessment Scores				
Material Assessment Score	Risk Rating	Approximate Extent/Area		
12	High Risk	10m2		
Photographic Reference

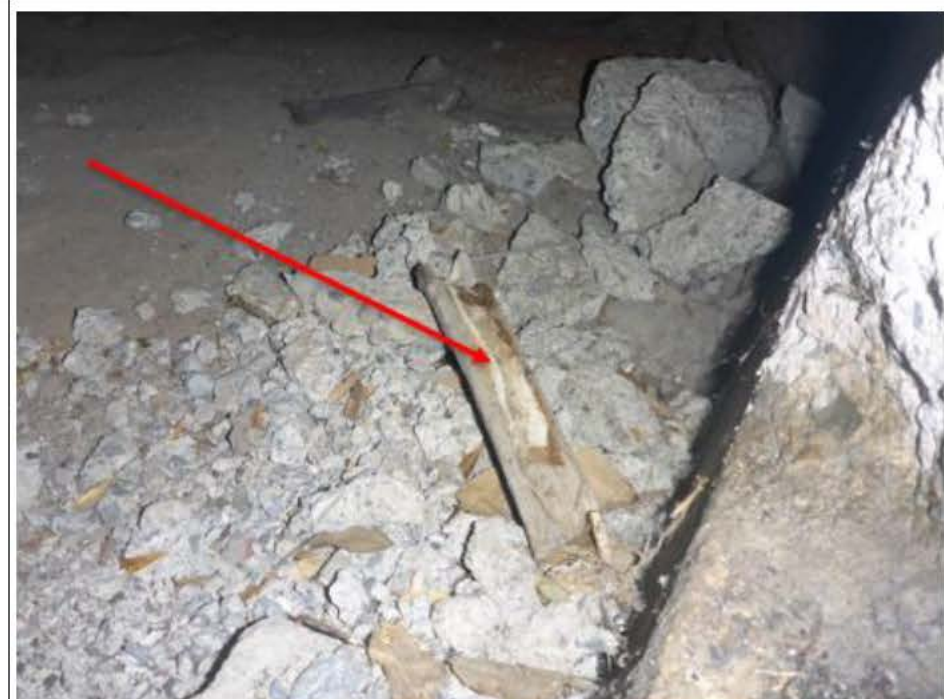
Unique No.	Description	Location	Result	Observations and Recommendations
190704SPAY003PS	Pipe Lagging / Fibre Cement Debris + ACD	All Buildings (West Wing, Central Block, East Wing), NZDF FLOC: NNK278 All Subfloor Areas - Throughout	Presumed to contain asbestos	Reference Sample 190704SPAY003SS - Various locations of friable ACM pipe lagging material and associated debris due to damage have been identified within the subfloor area. Prior to any refurbishment/demolition works that may disturb the items identified being undertaken, the asbestos identified must be removed. Removal of the asbestos must be undertaken by a licensed asbestos removalist in accordance with Health and Safety at Work (Asbestos) Regulations 2016.
Assessment Scores				
Material Assessment Score	Risk Rating	Approximate Extent/Area		
12	High Risk	Unable to Determine		
Photographic Reference

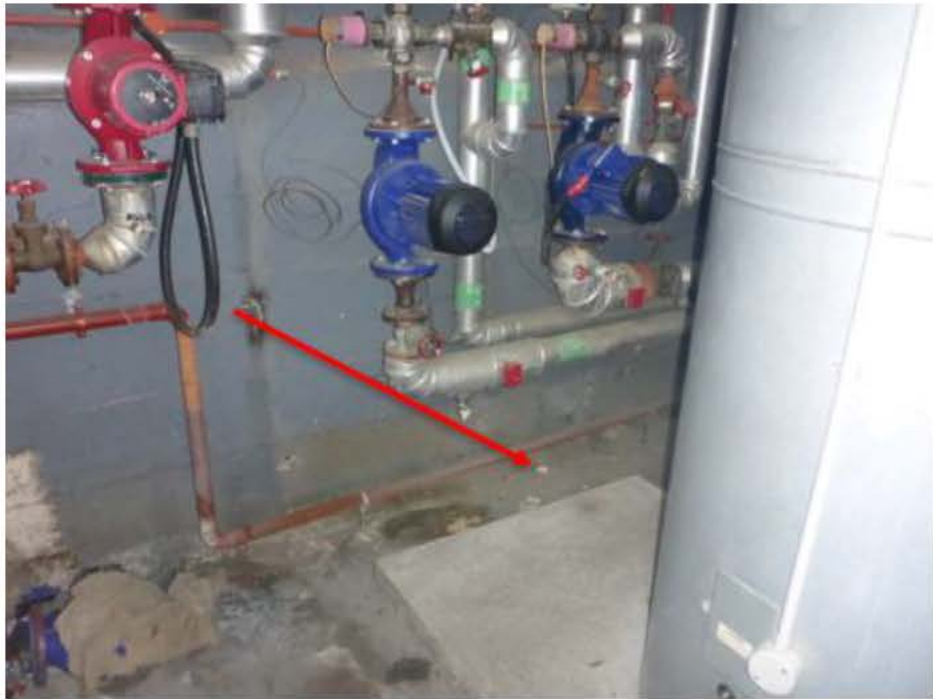
Unique No.	Description	Location	Result	Observations and Recommendations
190704SPAY006SS	Surface Sample - Tape Swab - Dust / Debris	Central Block, NZDF FLOC: NNK278 Boiler Room - Cable tray to Control Panel	Chrysotile (White Asbestos) detected	Prior to any refurbishment/demolition works that may disturb the items identified being undertaken, the asbestos identified must be removed. Removal of the asbestos must be undertaken by a licensed asbestos removalist in accordance with Health and Safety at Work (Asbestos) Regulations 2016.
Assessment Scores				
Material Assessment Score	Risk Rating	Approximate Extent/Area		
10	High Risk	Unable to Determine		
Photographic Reference

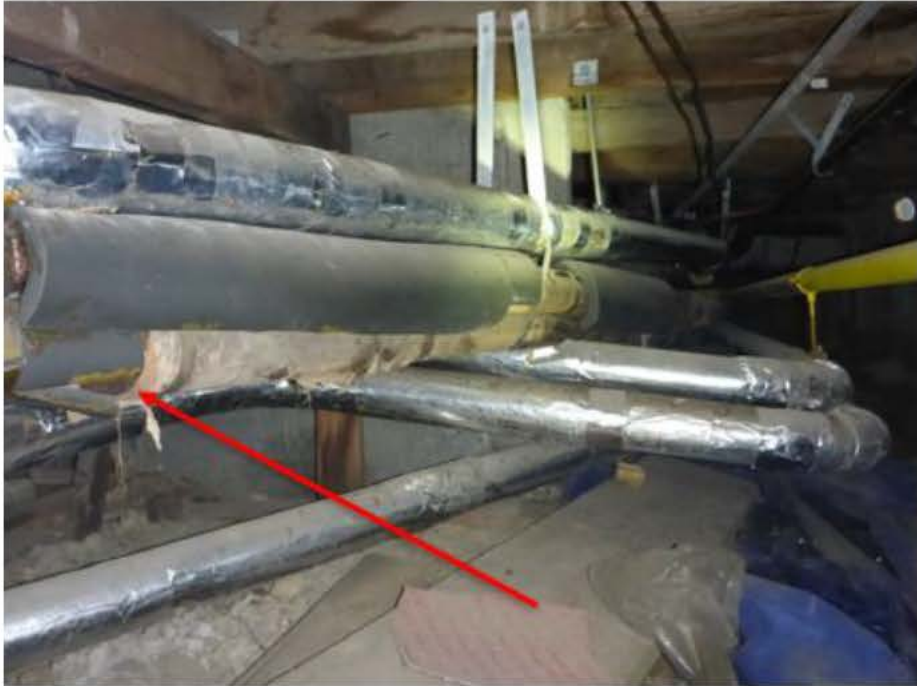
Unique No.	Description	Location	Result	Observations and Recommendations
190704SPAY008	Debris - Gasket Sheet	Central Block, NZDF FLOC: NNK278 Boiler Room - Penetration to Subfloor Area - Upon ground	Chrysotile (White Asbestos) detected	Prior to any refurbishment/demolition works that may disturb the items identified being undertaken, the asbestos identified must be removed. Removal of the asbestos must be undertaken by a licensed asbestos removalist in accordance with Health and Safety at Work (Asbestos) Regulations 2016.
Assessment Scores				
Material Assessment Score	Risk Rating	Approximate Extent/Area		
10	High Risk	1m2		
Photographic Reference

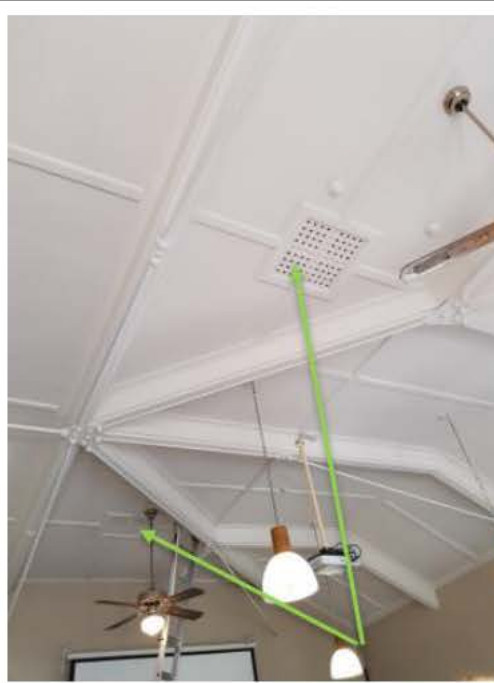
<p>MaynardMarks PROPERTY & BUILDING CONSULTANTS</p> <p>190711JADL005SS</p> <p>Asbestos Not Detected Targeted Asbestos Inspection Risk 278</p> <p>NZDF-A-2460 May 2019</p> <p>Location Plans</p>

Unique No.	Description	Location	Result	Observations and Recommendations
190711JADL006SS	Surface Sample - Tape Swab (Composite)	Central Block, NZDF FLOC: NNK278 Anteroom - Floor Surfaces below High Level Ceiling Vents	Asbestos NOT detected	N/A
Assessment Scores				
Material Assessment Score	Risk Rating	Approximate Extent/Area		
N/A	N/A	Unable to Determine		
Photographic Reference

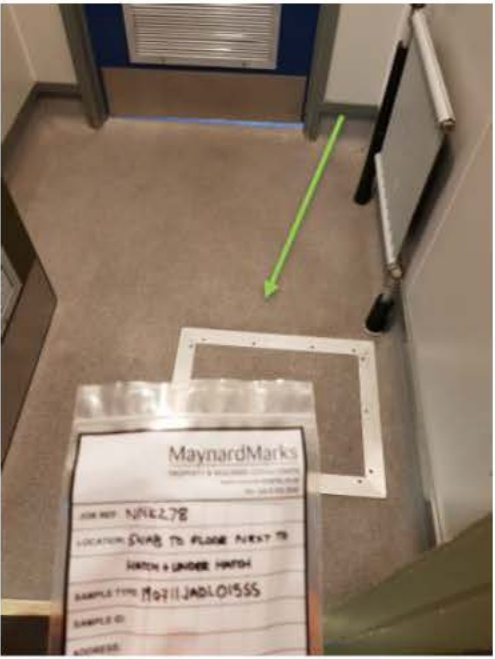
<p style="font-size: small;">MaynardMarks PROPERTY & BUILDING CONSULTANTS JOB NO: NNK278 LOCATION: SWAB TO FLOOR NEXT TO HATCH & UNDER HATCH SAMPLE TYPE: 190711JADL015SS SAMPLE ID: ADDRESS:</p>

Unique No.	Description	Location	Result	Observations and Recommendations
190711JADL015SS	Surface Sample - Tape Swab (Composite)	Central Block, NZDF FLOC: NNK278 Ground Level Female Bathrooms - Floor Below Ceiling Access Hatch and adj Subfloor Access	Asbestos NOT detected	N/A
Assessment Scores				
Material Assessment Score	Risk Rating	Approximate Extent/Area		
N/A	N/A	Unable to Determine		
Photographic Reference

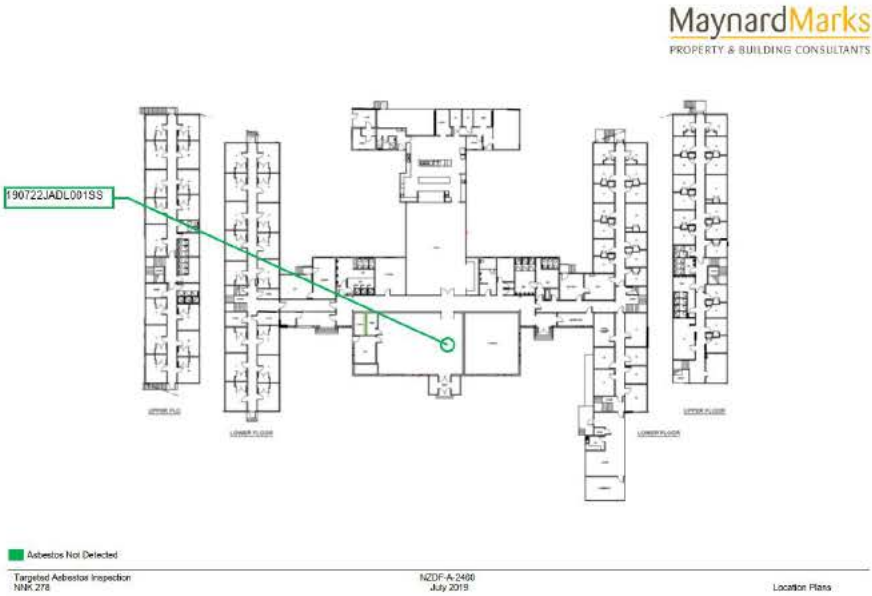
Unique No.	Description	Location	Result	Observations and Recommendations
190722JADL001SS	Surface Sample - Tape Swab (Composite)	Central Block, NZDF FLOC: NNK278 Gunroom - Pool Table	Asbestos NOT detected	N/A
Assessment Scores				
Material Assessment Score	Risk Rating	Approximate Extent/Area		
N/A	N/A	N/A		
Photographic Reference

<p style="text-align: right;">MaynardMarks PROPERTY & BUILDING CONSULTANTS</p> <p>190722JADL001SS</p> <p>Asbestos Not Detected</p> <p>Targeted Asbestos Inspection NNK 278</p> <p>NZDF-A-2460 July 2019</p> <p>Location Plans</p>

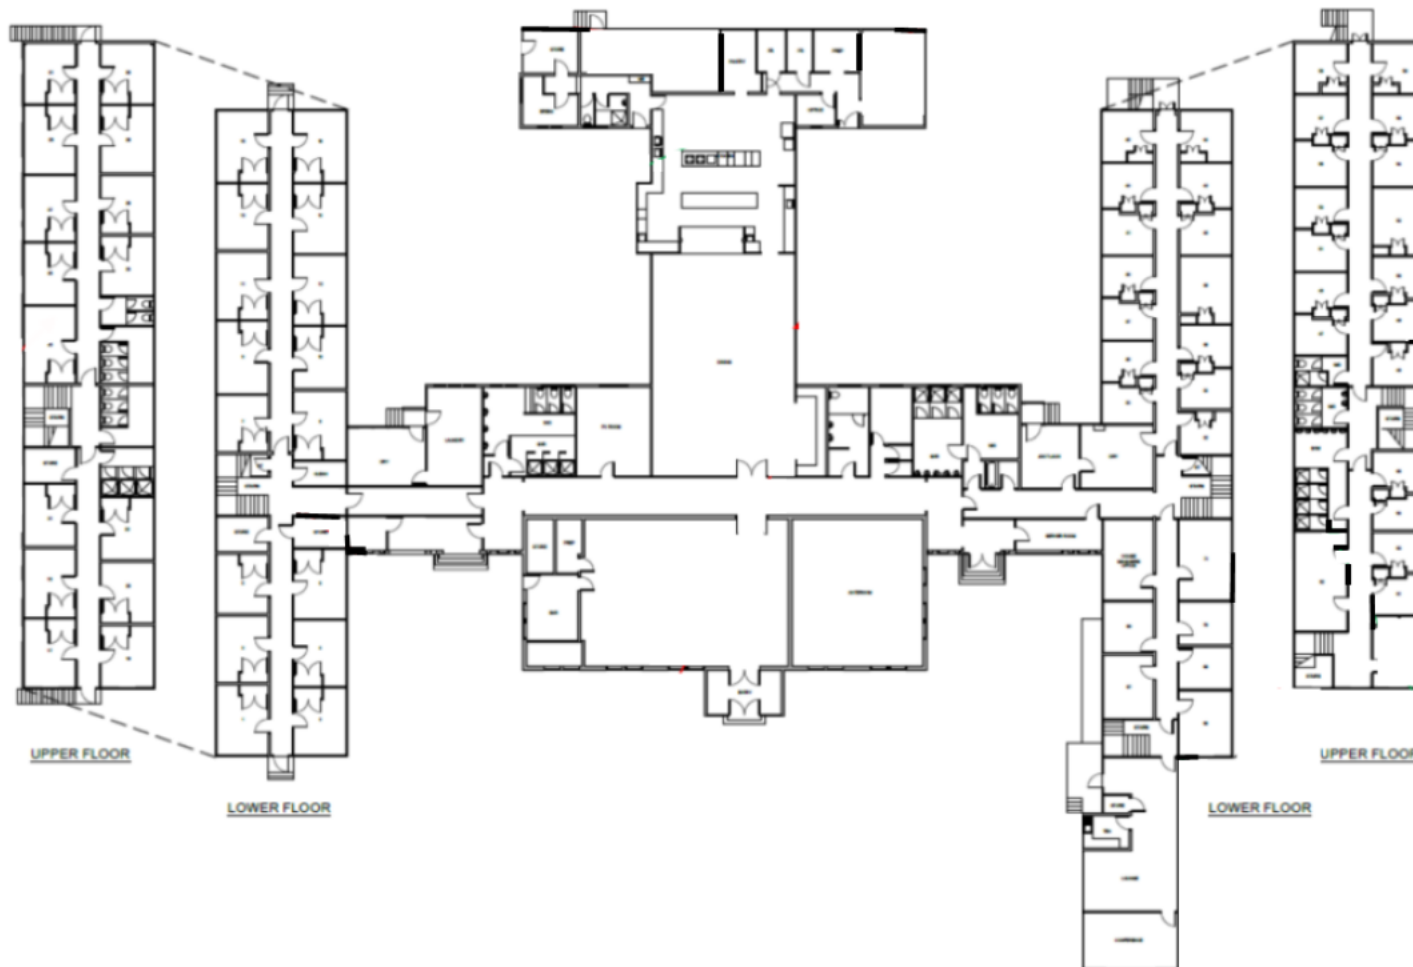
- Asbestos Detected
- Presumed to contain Asbestos
- Calico wrapped Pipework (Presumed Potable Water) - 190704SPAY0 7SS
- SMF Wrapped Pipework (Presumed Non Potable Water)

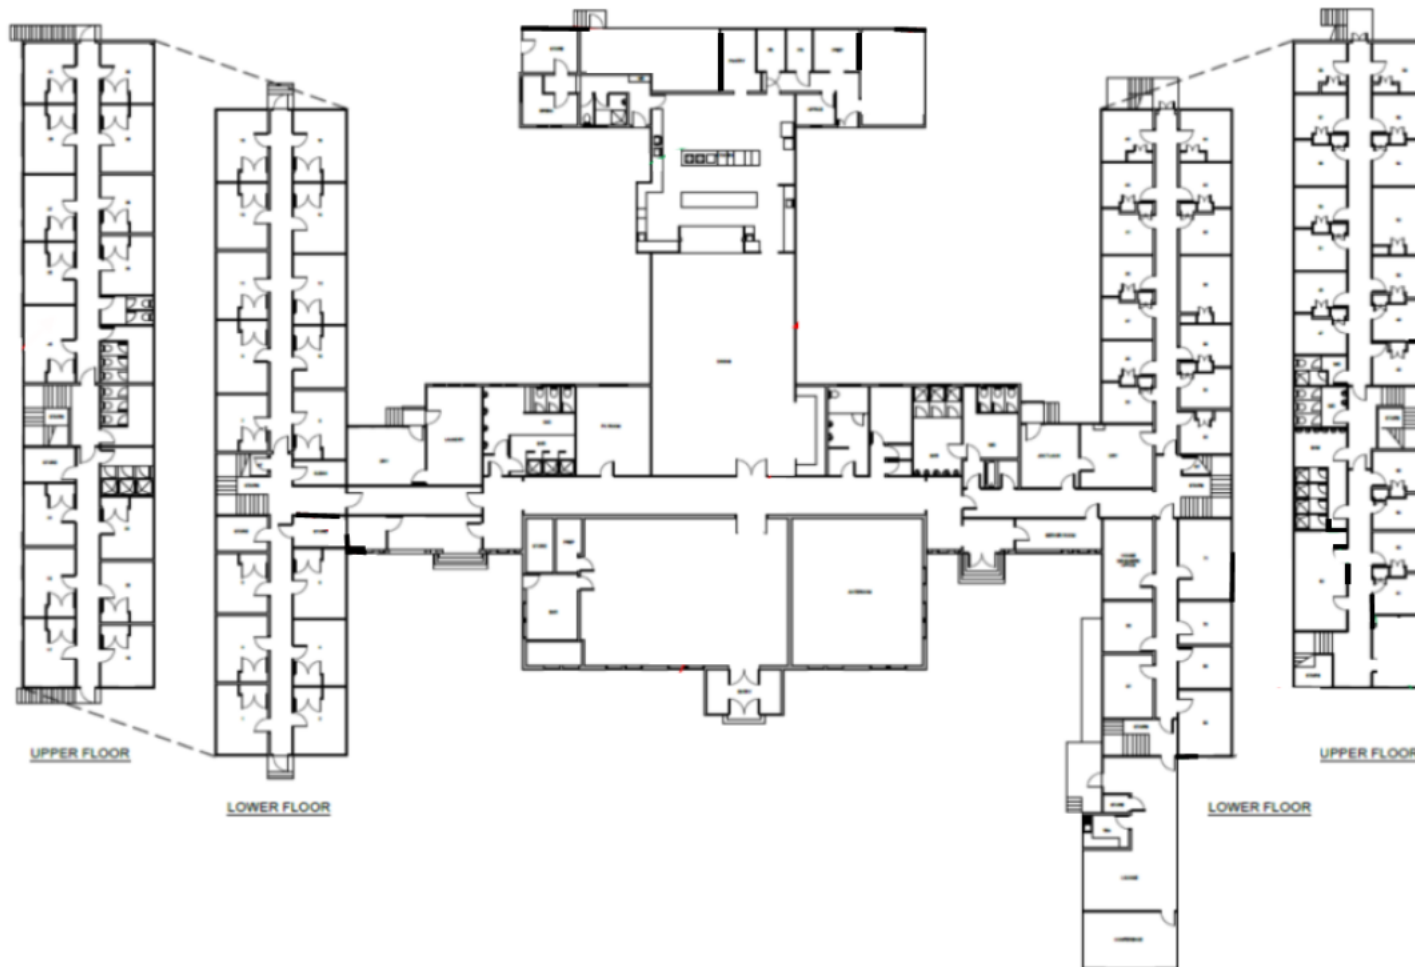
- Asbestos Detected
- Presumed to contain Asbestos
- Calico wrapped Pipework (Presumed Potable Water) - 190704SPAY0 7SS
- SMF Wrapped Pipework (Presumed Non Potable Water)

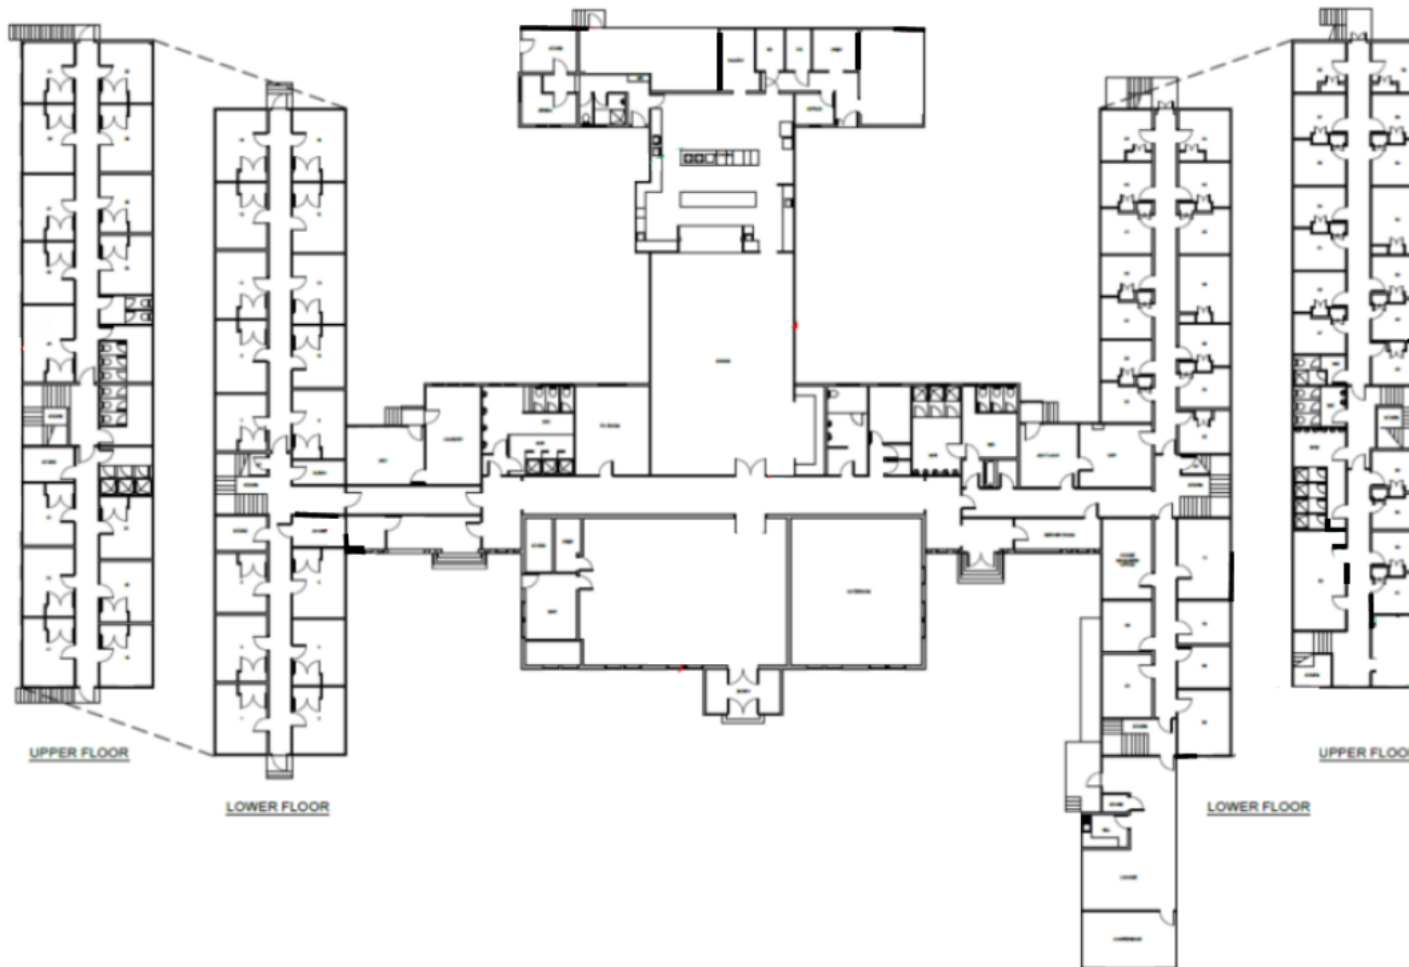
Subfloor - Areas Not Accessed

Subfloor - Areas Not Accessible for Inspection

Central Block Roof Void - Areas Not Accessed
